# Service Bulletin

Subject: ENGINE CRANKS NO START	Bulletin No:	01-048/06
	Last Issued:	11/17/2005

2004-2007 RX-8

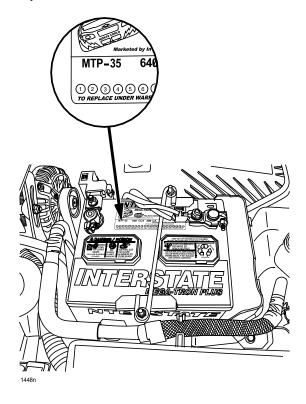
- Interstate brand "MTP35" battery.
  - If the vehicle's battery type matches one of the following descriptions, proceed to STEP 2.
  - If the vehicles battery type does not match the above descriptions, replace with Mazda Genuine replacement battery # 0000-80-6535-WB. Proceed to STEP 3 after battery replacement.

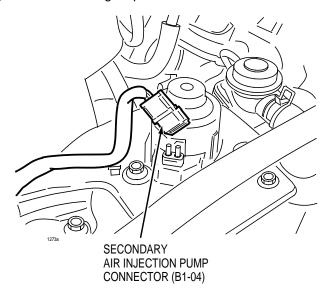
This will protect the catalytic converter by preventing rapid light off due to unburned fuel purging from the engine in the following steps.

3. Disconnect the secondary air injection pump electrical connector (B1-04).

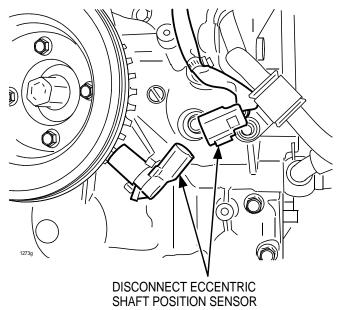
• This will cut fuel injection and spark while performing the procedure.

- The following steps will force un-burnt fuel from the combustion chambers through the spark plug holes. Use caution not to create sparks or other sources of ignition during these steps. Perform this procedure in a well ventilated area.
- 4. Remove all 4 spark plugs from the engine. See workshop manual section 01-18 SPARK PLUG REMOVAL / INSTALLATION.
- 5. Disconnect Eccentric Shaft Position Sensor (ESPS) B1-27.

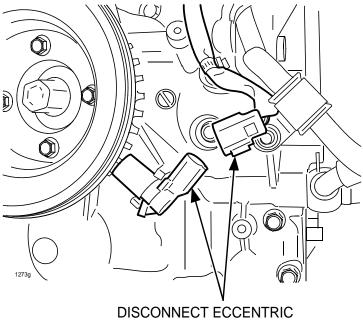
DISCONNECT ECCENTRIC SHAFT POSITION SENSOR

This will cut fuel injection & spark while performing the procedure.

1. Disconnect Eccentric Shaft Position Sensor (ESPS) B1-27.

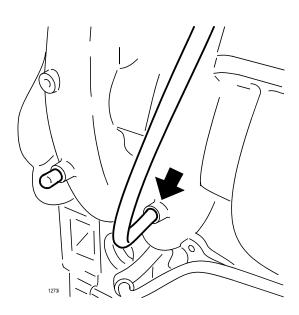
• DO NOT attempt to service both vacuum ports at the same time. Perform procedure for front port, then perform procedure for rear port.

- 2006 model year and later vehicles have vacuum hoses attached to these ports for the PCV system. Disconnect these hoses from the lower intake manifold ports one at a time when performing this procedure. These hoses do not need to be plugged once disconnected.
- 3. Fabricate a vacuum line (About 2 feet in length) & attach to front vacuum port as shown in the illustration.

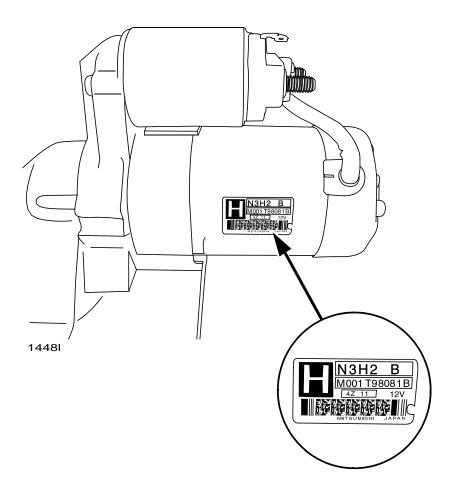
# **AUTOMATIC TRANSMISSION**

- 1. Is the VIN at or below JM1FE17N\* \*\* 148961?
  - NO Starter replacement is not necessary, go to STEP 11 in REPAIR PROCEDURE "A".
  - YES Go to STEP 2.
- 2. Inspect vehicle's starter label to determine starter type. Starter label can be seen under hood on driver's side.
  - If label indicates "N3H2 A", replace starter. See workshop manual section 01-19 STARTER REMOVAL / INSTALLATION. After starter replacement, go to STEP 11 in REPAIR PROCEDURE "A".
  - If label indicates "N3H2 B", "N3Z2" or later, do not replace starter, go to STEP 11 in REPAIR PROCEDURE "A".

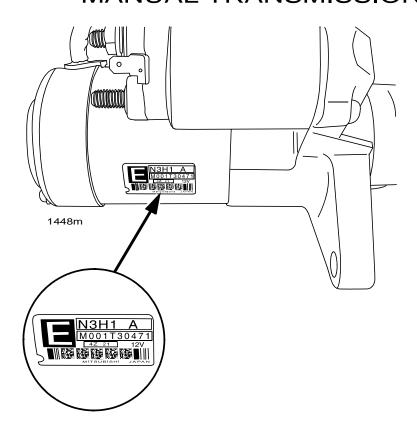
# MANUAL TRANSMISSION

- 1. Is the VIN at or below JM1FE173\*\*\* \*\* 150745?
  - NO Starter replacement is not necessary, go to STEP 11 in REPAIR PROCEDURE "A".
  - YES Go to STEP 2.
- 2. Inspect vehicle's starter label to determine starter type. Starter label can be seen with vehicle on hoist and using a mirror.
  - If label indicates "N3H1", replace starter. See workshop manual section 01-19 STARTER REMOVAL / INSTALLATION. After starter replacement, go to STEP 11 in REPAIR PROCEDURE "A".
  - If label indicates "N3H1 A", "N3Z1" or later, do not replace starter, go to STEP 11 in REPAIR PROCEDURE "A".

- When installing the new starter, use care that the starter terminals "B" and "S" and related wire harness do not come in contact with the heat shield. Clearance between the heat shield and the terminals should be as follow:
  - 10mm between corner of heat shield and White "B" terminal cover.
  - 15mm between heat shield and Black "S" terminal connector.
- If clearance is not as specified, bend heat shield as necessary. Ensure that after bending heat shield at least 10mm clearance is present between bent section of heat shield and vehicle body.
- USE CARE THAT THE BLACK "S" TERMINAL CONNECTOR DOES NOT COME IN CONTACT WITH HEAT SHIELD AFTER INSTALLATION.
