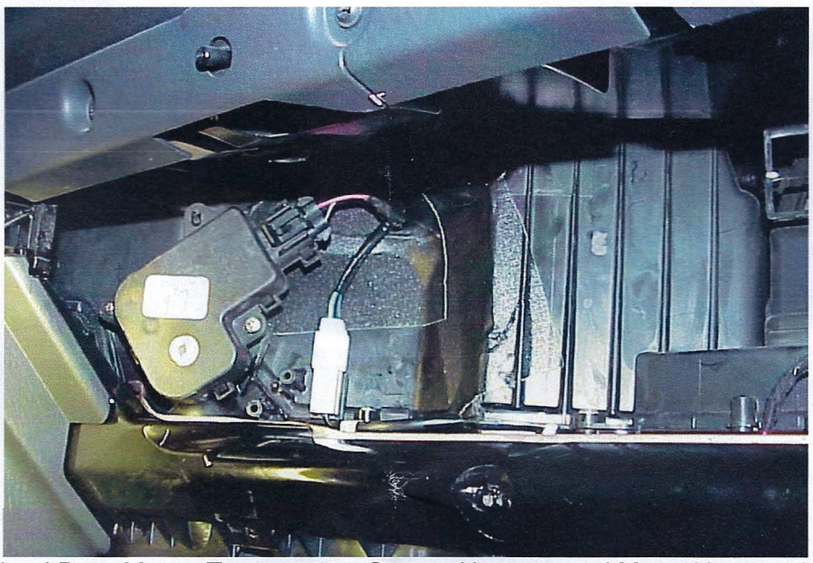
(Figure 10. Blend Door Motor, Temperature Sensor Harness and Motor Harness Installed)

24. Re-set the Automatic Zone Control system; **disconnect the negative battery terminal for 15 seconds and re-connect it.**
25. Test and verify that all system mode settings function. The system should recalibrate and function normally after step 24. Their will no longer be any active codes fault codes.
26. Install the Glove Box Door.
27. With a shop vacuum; clean up all the remaining debris in the vehicle's interior.
28. Reset the radio clock to the correct time.
