TIME-SERT® FORD TRITON M16x1.5 3 VALVE SPARK PLUG REPAIR KIT P/N 3221

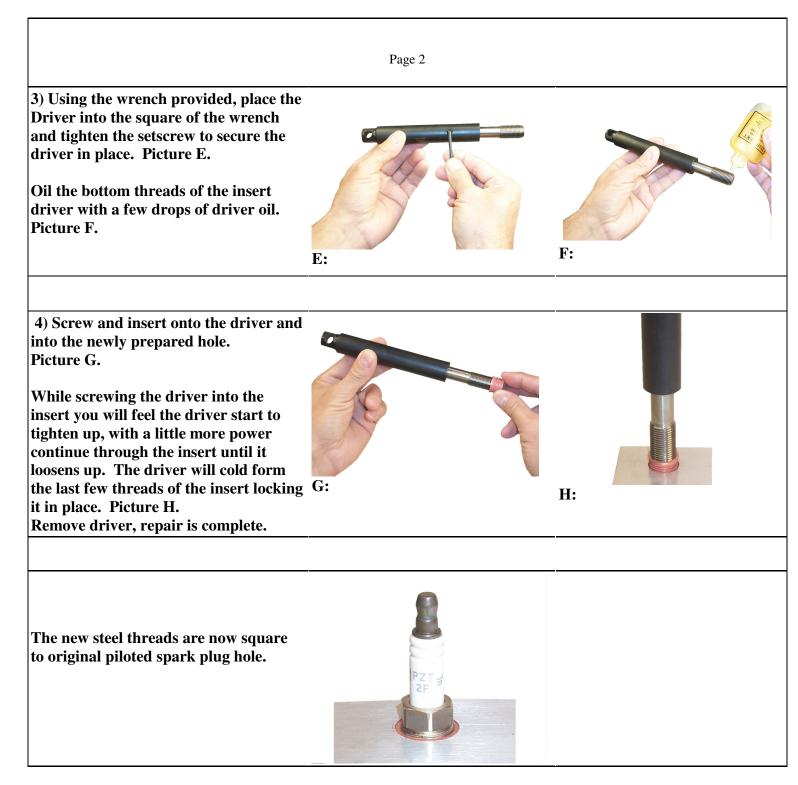
Use contact or brake cleaner to thoroughly clean out any remaining chips and oil.
